Near infrared imaging (NIRI) technology in dentistry - iTero Element 5D.

This clinical guide presents the promising features of the iTero Element 5D Imaging System designed with NIRI technology and its application into every day dentistry. NIRI technology of the iTero Element 5D aids in detection and monitoring of interproximal caries lesions above the gingiva without using harmful radiation.

Author: Dr. Priyanka Keshav BDS, iTero Global Education

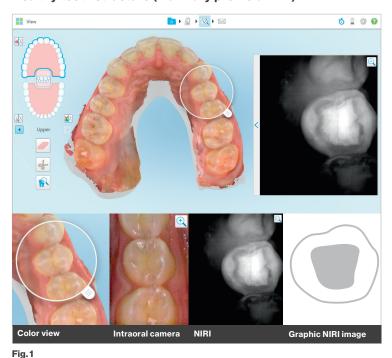
Case presentation 1: Healthy tooth structure (maxillary premolar #12)

Figure 1: Image demonstrating the left maxillary premolar #12 as seen in NIRI. A uniformly dark outer enamel layer with a bright center indicating the dentin is a classic example of a healthy tooth structure with no apparent lesions, note the constrast between the enamel-dentin provides a clear, appreciable demaraction between the two.

When examined in multiple modes (color view, intraoral camera view and NIRI) comparisons can be made to aid in differential diagnosis; in this case, uniform color of the tooth with no apparent discoloration or loss of structural integrity indicates the presence of a healthy tooth.

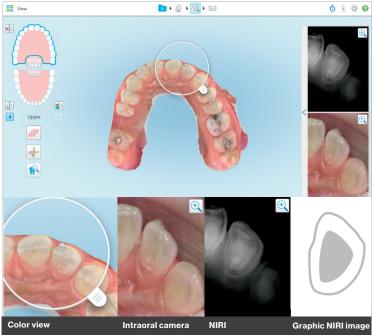
Fig. 2

Figure 2: Image showing (#10) left maxillary lateral incisor with an Invisalign attachment on the buccal. Inspection of the occlusal surface under NIRI suggests a healthy tooth structure with no evidence of carious lesions or enamel demineralization.

Note: The presence of attachments in this case does not have any negative effect on the NIRI image.

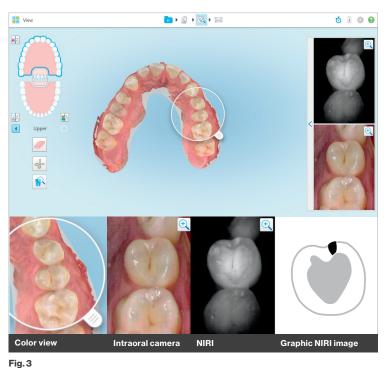
Case presentation 3: Proximal carious lesion (maxillary premolar #13)

Figure 3: A bright spot in the mesial aspect of the left maxillary premolar indicates the presence of a proximal carious lesion. The position of #12 (rotated and inclined) in relation to #13 creates a narrow area which is difficult to clean and may favor accumulation of food and debris over time. Note in the image from the intraoral camera there is no evidence of underlying carious activity.

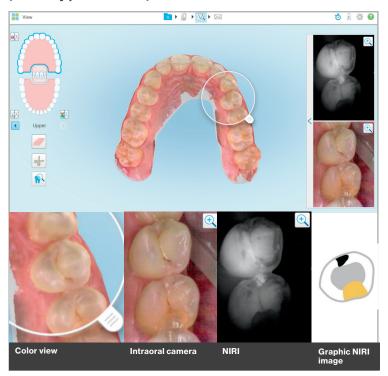
Fig. 4

Figure 4: A mesial bright spot in the left maxillary premolar (#13) indicates the presence of a carious lesion. Note the distal of #13 presents with a dark area, on comparison with the color image from the intraoral camera, the presence of an existing composite restoration is confirmed.

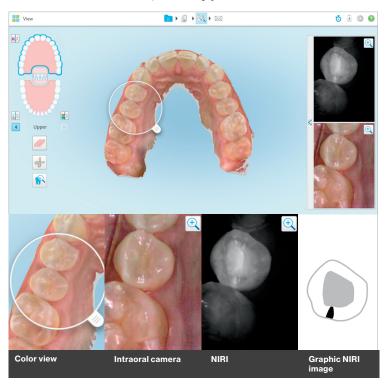
Fig. 5

Figure 5: NIRI image of #4 indicates a bright wedge shaped area advancing towards the DEJ suggesting the presence of carious activity.

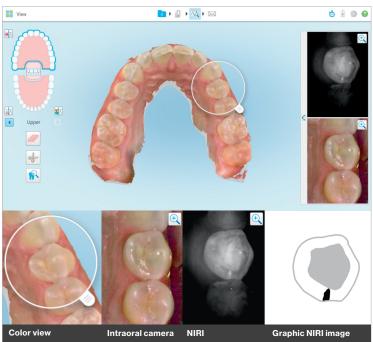
Color view Intraoral camera NIRI Graphic NIRI image
Fig. 6

Figure 6: NIRI image of #12 indicates the presence of a proximal carious lesion (distal).

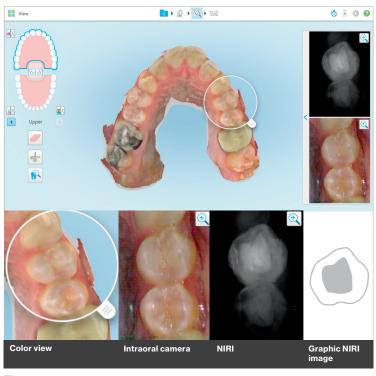
Fig.7

Figure 7: Image showing (#12) left maxillary premolar, corresponding NIRI image suggests a healthy tooth structure with no evidence of carious lesions or enamel demineralization

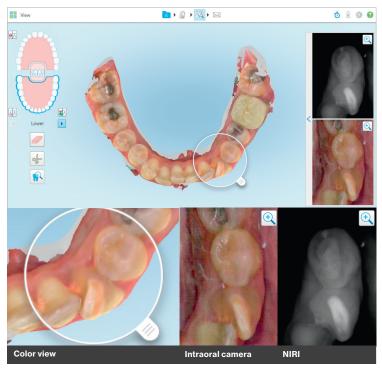
Fig. 8

Figure 8: Dental flurosis is one of the most common disorders of the enamel presenting with characteristic permanent discoloration. This case is particularly interesting as is it shows the ability of NIRI to detect the changes in the structural integrity of enamel. Note: Instances like these may mimick the presence of caries, in such instances it is valueable to make comparisons with color images before arriving at a conclusion. Also seen in this image is a distal interproximal carious lesion on #21.

Instances mimicking interproximal caries: Teeth involving enamel demineralization conditions such as tooth wear, enamel hypoplasia and fluorosis (as seen in case 7) may mimic the presence of interproximal caries under NIRI; some dental cements (such as oxides and phosphates) may also exhibit the same behavior on interaction with NIRI, best practices to avoid misinterpretation in such cases would be to compare the NIRI images with the color images from the scan and other applicable examination techniques.

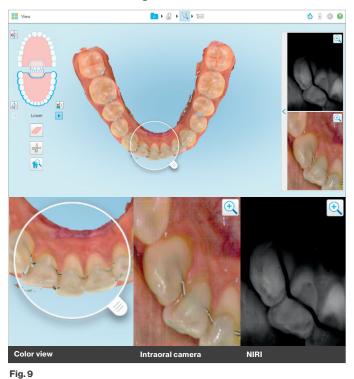
Case presentation 9: Bonded mandibular lingual arch wire

Figure 9: Image shows a good example of a bonded lingual arch wire in the mandibular anteriors. Note: The NIRI image remains abolsutely clear of any obstacles and ready for interpretation.

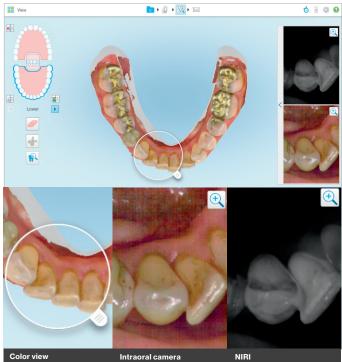
Fig. 10

Figure 10: Stains are commonly seen in the mouth especially in individuals who have a habit of smoking. The above image suggests that stains do not have any significant effect on the resultant NIRI image.

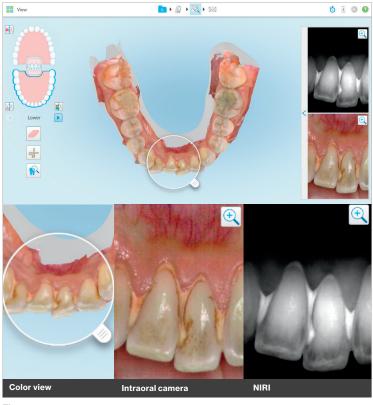
Fig. 12

Figure 12: The formation of calculus can be triggered by multiple factors; most commonly diet, poor oral hygiene, systemic disease or medication. The presence of calculus does not have any significant effect on the tooth in NIRI; Calculus itself presents as areas of brightness in NIRI.

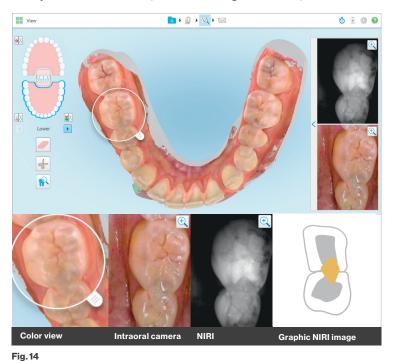
Case presentation 14: Composite restoration (mandibular right #29#30)

Figure 14: Composite restoration in the distal of #29 and mesial of #30 presents as a dark area which is comparitively dull in constrast when compared with the adjacent structures. The inability of Near infrared light to pass through existing restoration results in the presentation of a dark area.

Limitations of the technology: Current limitations of the technology are mostly around existing restorations. In the presence of restorations such as amalgam or composite resins, NIRI is unable to penetrate through the structure of the tooth. The insufficient data from the scan in these scenarios causes a blurry, dark and ill-defined resultant image that is not suitable for examination.

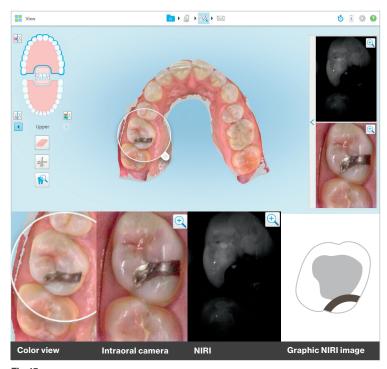
Fig. 15

Figure 15: Exisiting amalgam restorations (as seen to the left). Amalgam being an alloy creates a highly scattering effect on Near infrared light resulting in a dark image with ill defined anatomical landmarks which makes the image unsuitable for interpretation. In such cases, comparison with other available data is recommended.
